# Pitting corrosion of the stainless steel ventilation duct in a roofed swimming pool

P. Sędek <sup>a</sup>, J. Brózda <sup>a,\*</sup>, J. Gazdowicz <sup>b</sup>

## Abstract

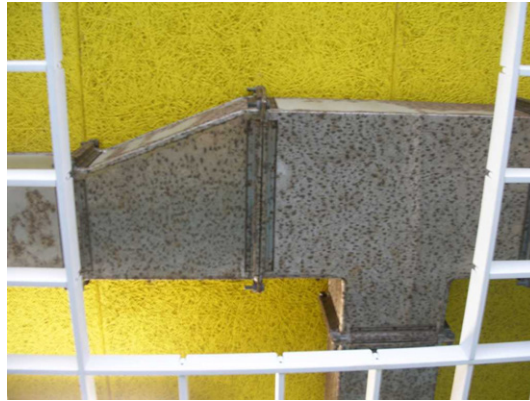
In the swimming pool of a secondary school an uptake ventilation duct made of austenitic steel has been installed. After 2 years service, corrosion pits have been observed on the external surface of the ventilation duct elements (Fig. 1), but only few corroded areas were visible on the internal surface.

Fig. 1. Ventilation duct with corroded surface.

2. The corrosion resistance of the X10CrNi18-8 steel is insufficient in that highly corrosive environment and should be replaced in the new installation by a higher alloyed Mo containing austenitic steel with a lower carbon content.
3. The assembly elements need also a new design, to avoid the possibility of crevice corrosion.

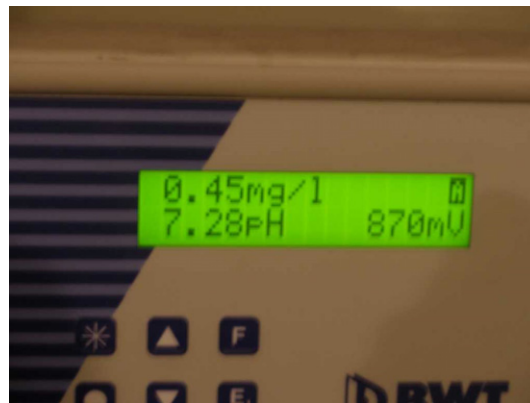
The water in the swimming pool is chlorinated by a special unit with a possibility of precise dosing of chlorine and monitoring of its content. According to the documentation, the chlorine concentration should be maintained at the limits of 0.3–0.5 mg/l, and the pH value should be kept in the range of 6.8–8.0. As shown on the display of the unit (Fig. 2) both values are maintained.

Fig. 2. Display of the chlorine concentration and pH value in the swimming pool water.

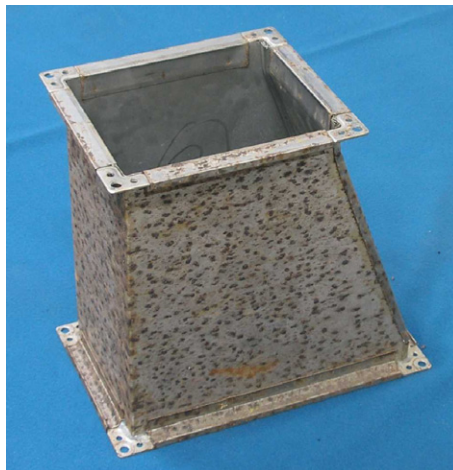
Fig. 3. View of the corroded ventilation duct element delivered for examination.

Visual examination of the ventilation duct element shown in Fig. 3, made of austenitic steel sheet 0.6 mm in thickness, has revealed, that the corrosion pits are present mainly on its external surface. On the internal sur-

On the internal surface of the ventilation duct sheet only a few corrosion spots can be observed (Figs. 3 and 4). The reason is a high rate of air flow through the duct, which prevents the condensing of chlorinated water on the sheet surfaces.

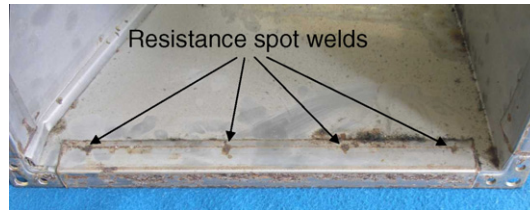
face some corrosion centres are visible in the area of the assembly flange, which was resistance spot welded to the ventilation duct body (Fig. 4).

Fig. 4. Inside view of the ventilation duct element with corrosion centres close to the spot welded assembly flange.

As mentioned before, on the internal surface of the ventilation duct (Fig. 4) some corrosion centres are located at the assembly flange spot welded to the stainless steel sheet. It is crevice corrosion formed as a result of the gap between the flange and ventilation duct sheet. That kind of design should be avoided at high corrosion hazards.

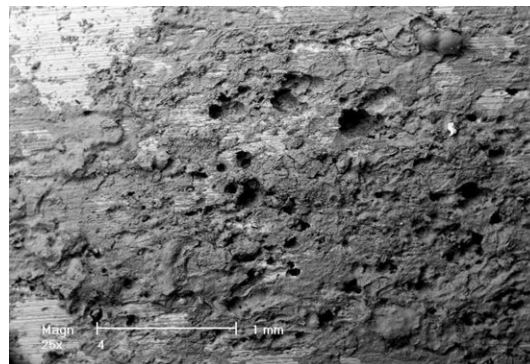
The appearance of the corroded surface of the ventilation duct is shown in Fig. 5. Some corrosion pits have penetrated the sheet to a considerable depth (Fig. 6).

Fig. 5. The ventilation duct sheet with corrosion pits and deposits (SEM).

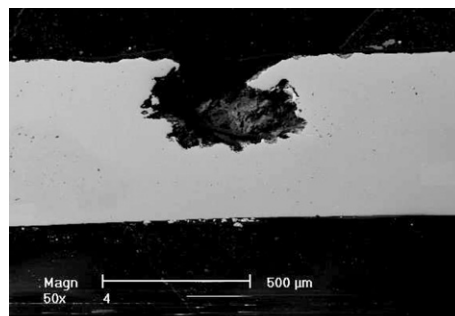
Fig. 6. Corrosion pit on the cross section of the ventilation duct sheet (SEM).

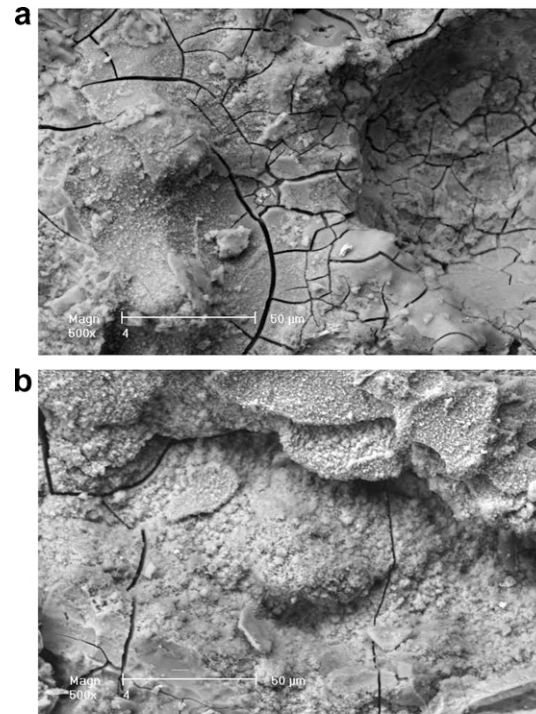
Element	A		B	
	% mass	% at.	% mas	% at.
O	7.41	19.06	9.68	25.10
Si	0.85	1.25	0.42	0.62
Cl	25.85	30.01	16.18	18.93
Cr	30.63	24.25	14.77	11.78
Mn	0.30	0.23	0.28	0.21
Fe	19.17	14.13	53.08	39.41
Ni	15.78	11.07	5.59	3.95

Fig. 7. Microanalysis results of chemical composition of two types deposits.

The high concentration of chlorine in the deposits on the stainless steel sheet surface (Fig. 7) and its lower content in the deposit inside the corrosion pit (Fig. 8) are the evidence of the described above corrosion mechanisms which took place on the ventilation duct exposed to the environment of the roofed swimming pool with chlorinated water.

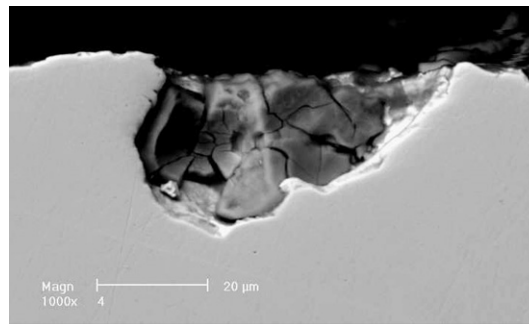
Some pits are filled with corrosion deposits, which chemical composition differs from those on the surface (Fig. 8).

Element	% mass	% at.
O	6.60	18.75
Si	0.85	1.38
Cl	5.37	6.89
Cr	39.91	34.90
Fe	37.10	30.21
Ni	10.17	7.88

Fig. 8. Microanalysis chemical composition results of deposit inside the corrosion pit.
